Damming Rishiganga in Chamoli District on the aftermath of Flash Flood Disaster of February 7, 2021: Case Study

Sushil Khanduri^{1*}

¹Uttarakhand State Disaster Management Authority, Department of Disaster Management, Uttarakhand Secretariat, 4 Subhash road, Dehradun, Uttarakhand, India; sushil.khanduri@gmail.com; <https://orcid.org/0000-0002-2787-8337>

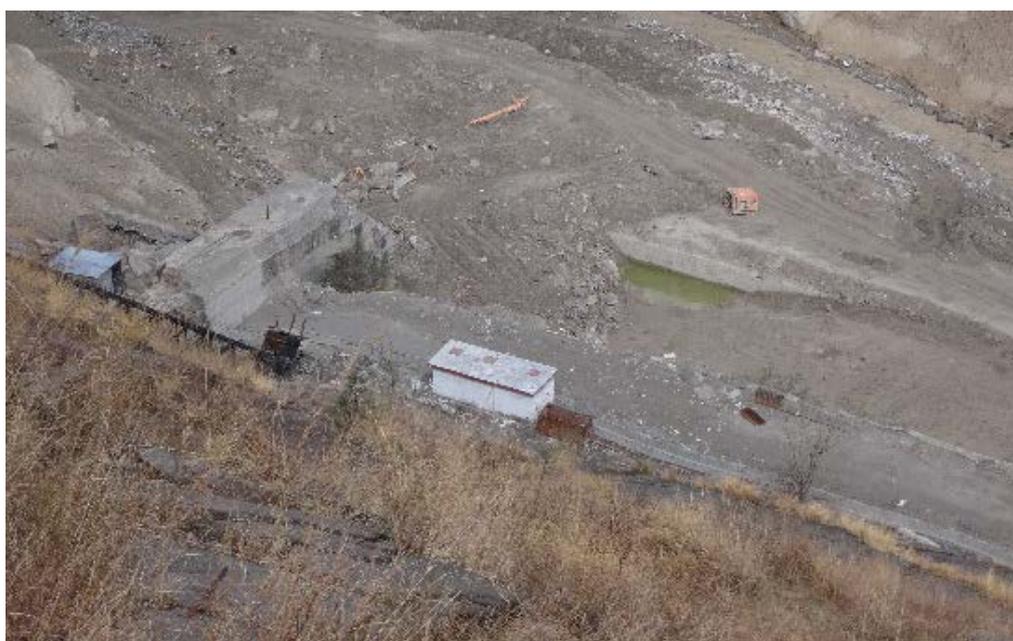
Figure 2. Washing away power house of Rishiganga hydropower project of 13.2 MW capacity upstream of Rini

Multipule intermittent damming and ensuing flash flood of Rishiganga and Dhauliganga river caused washed off a functional hydropower project of 13.2 Mw capacity on Rishiganga upstream of Rini (Figure 2) along with a RCC bridge of 60 m span over Rishiganga on Joshimath – Malari road at Rini in which disrupted connectivity for the people of 13 villages (Figure 3). To the downstream of this the floodwaters caused severe damage to another under construction hydropower project of 520 Mw of NTPC at Tapoban on Dhauliganga river (Figure 4). 204 people went missing, including 9 local people and 2 Police personnel, of these body of 83 persons could be recovered. Besides this heavy losses were incurred by public infrastructure and other properties.

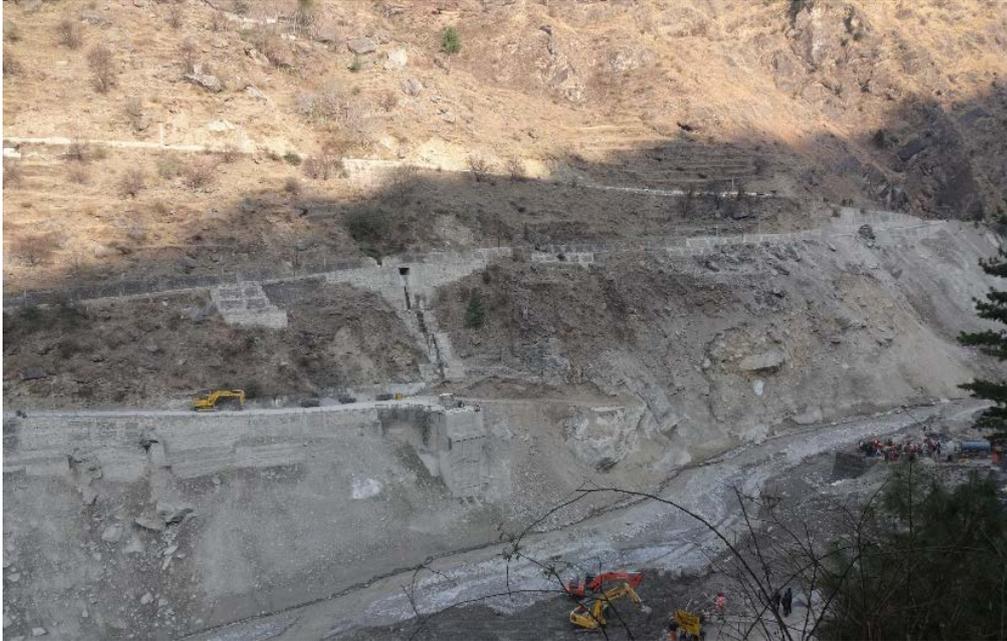
Figure 3. Washed off motorable RCC bridge over Rishiganga on Joshimath – Malari State Highway at Rini

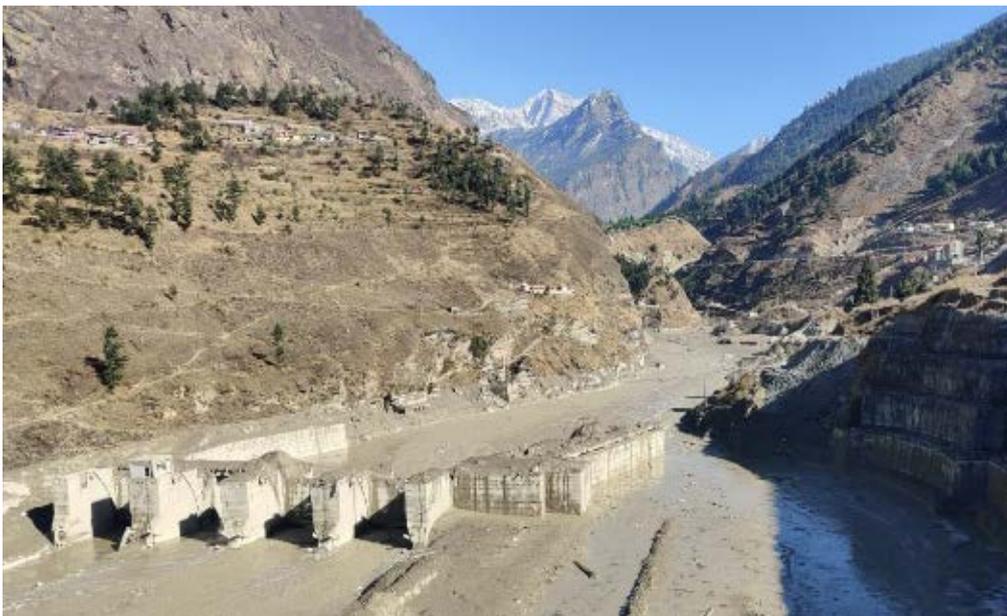
Figure 4. Severely damaged barrage of Tapoban-Vishnugad hydropower project with aggradation of river bed at Tapoban

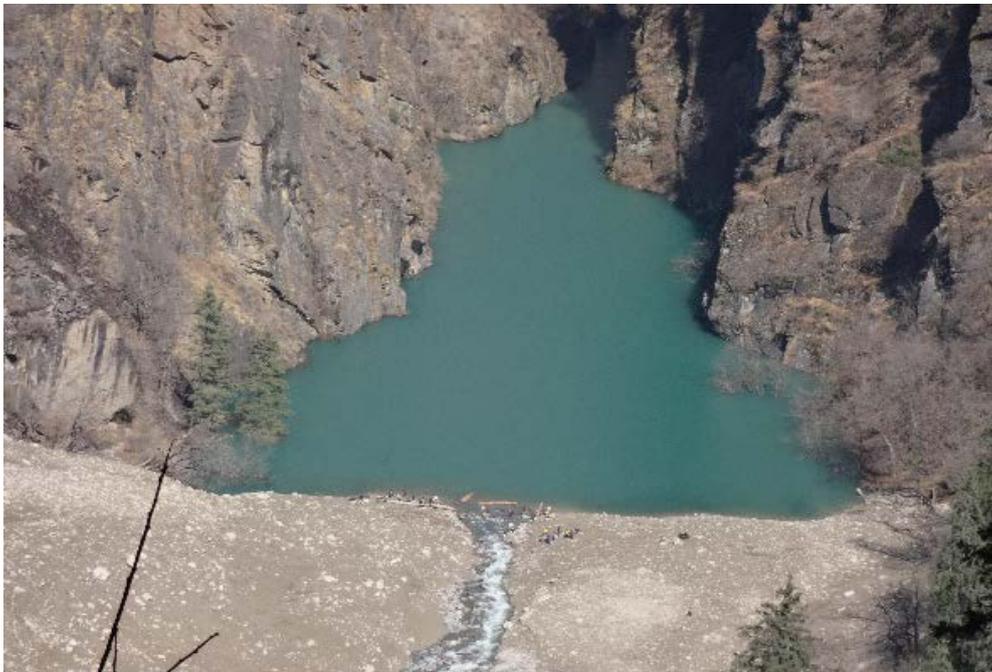
Figure 6. Rishiganga lake curved out channel from the center of the lake through which water is continuously draining out

This reverse flowed of a huge volume of water saturated bouldary debris was deposited over Rishiganga and blocked the course of the same for 3 days between 9 and 11 February, 2021. This debris comprising of a mixture of ice blocks, rock fragments, morainic materials and boulders of quartzite, granitic gneiss and mica schist with silty-clayey matrix. The Rishiganga was curved out channel from the center of the lake through which water is continuously draining out on February 12, 2021 (Figure 6).

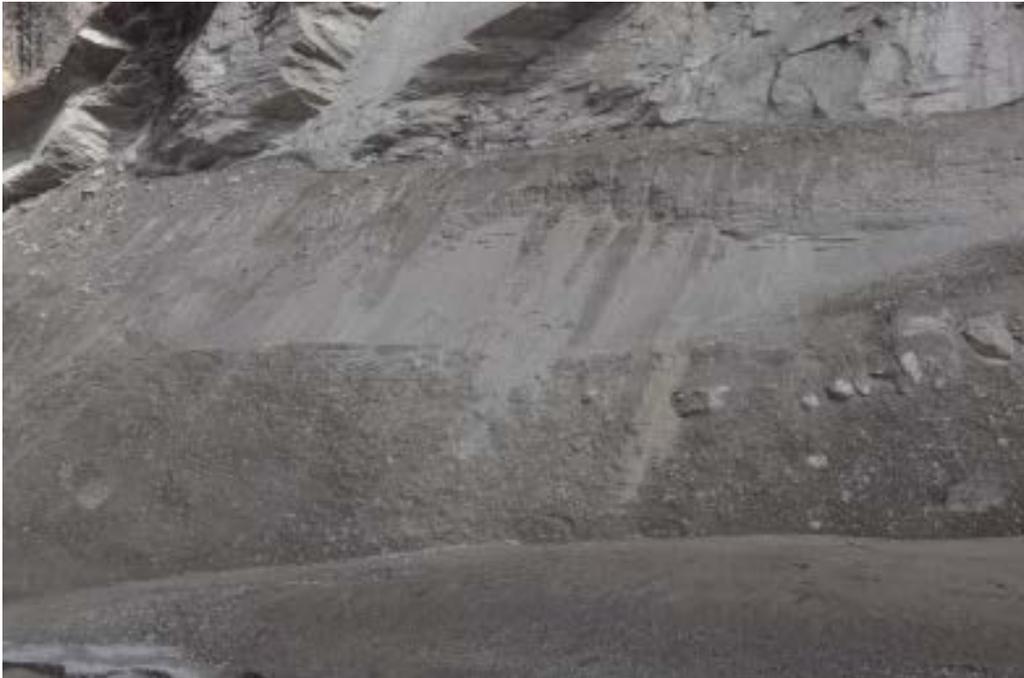
It is important to note that just upstream to confluence of Raunthi Gadhera and Rishiganga, occurrence of lacustrine deposits that consist a layers of sand and pebbles on the right bank of Raunthi Gadhera which was indicating evidence of paleo lake in the same region. These deposits has now been mostly eroded in the flash flood of Raunthi Gadhera (Figure 7).

Figure 7. Evidence of paleo lake showing lacustrine sediments on the right bank of Raunthi Gadhera near its confluence with Rishiganga

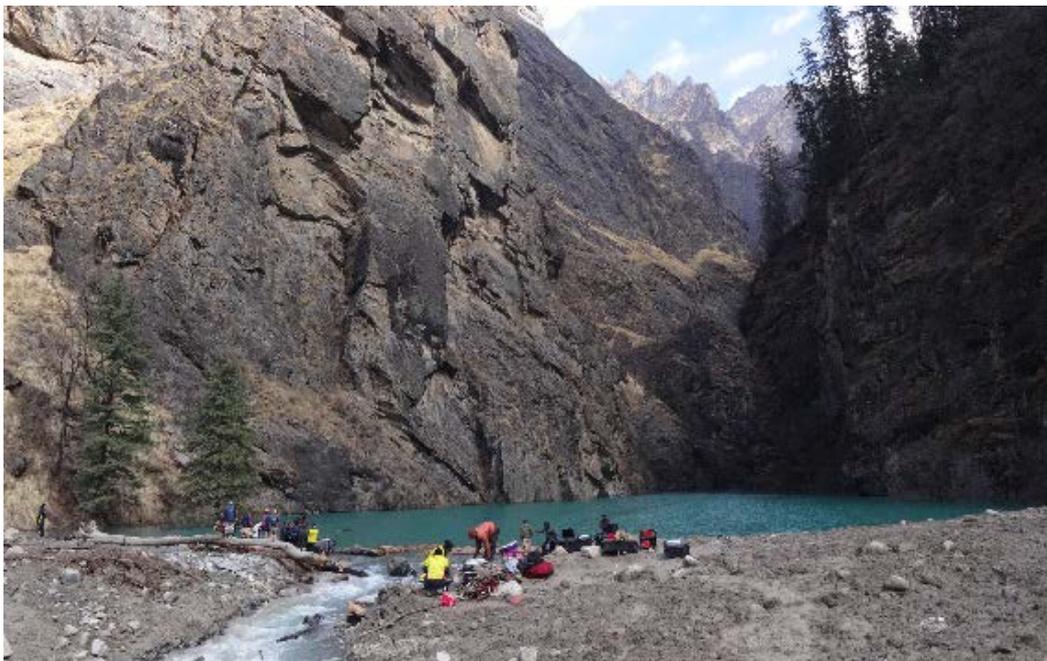
Figure 8. Personnel of ITBP and SDRF widen the channel and cleared of obstructions of logs

Continuously increasing hydrostatic pressure, temporary dam at confluence was breached, a huge debris mass along with boulders and ice was dumped over the course of the Rishiganga, left behind this sediments barrier water accumulated and formed an artificial lake. Between 9 and 11 February, 2021 the course of Rishiganga was permanently blocked by the debris brought down by the Raunthi Gadhera. The Rishiganga was curved out channel from the center of the lake through which water is continuously draining out on February 12, 2021. As directed to personnel of ITBP

and SDRF, physically widen the channel and cleared of obstructions of logs (Figure 8). The channel was thus widened upto 20 m between February 22 and March 2, 2021 to ensure proper draining out water from the lake.
